Coastal Engineering Technical Note

PLASTIC PILING JACKET FOR ICE PROTECTION

PURPOSE: To present a method for protecting piling against ice forces.

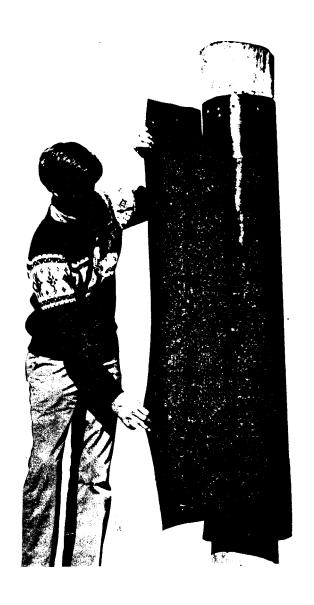
Figure 2. The Ice Jacket

The jacket, composed of patented carbon black impregnated polyethylene, is designed to fit standard piling with a simple wrap-around, nail-in

instaliation--(see Ngure 2). It is molded to conform to the cylindrical shape of a piling and is nailed in place using simple hand tools. The jacket has internally molded raised nodules graduated to create a reverse piling taper. This allows the ice sheet to move along the jacket as the water level changes, preventing the pile from being lifted from the bottom. The black jacket resists ice adhesion and absorbs heat from the sun, which helps melt the surrounding ice.
